Name of Dam: Buffalo River No. 3

Location: Amherst County, State of Virginia

# PHASE I INSPECTION REPORT

## NATIONAL DAM SAFETY PROGRAM

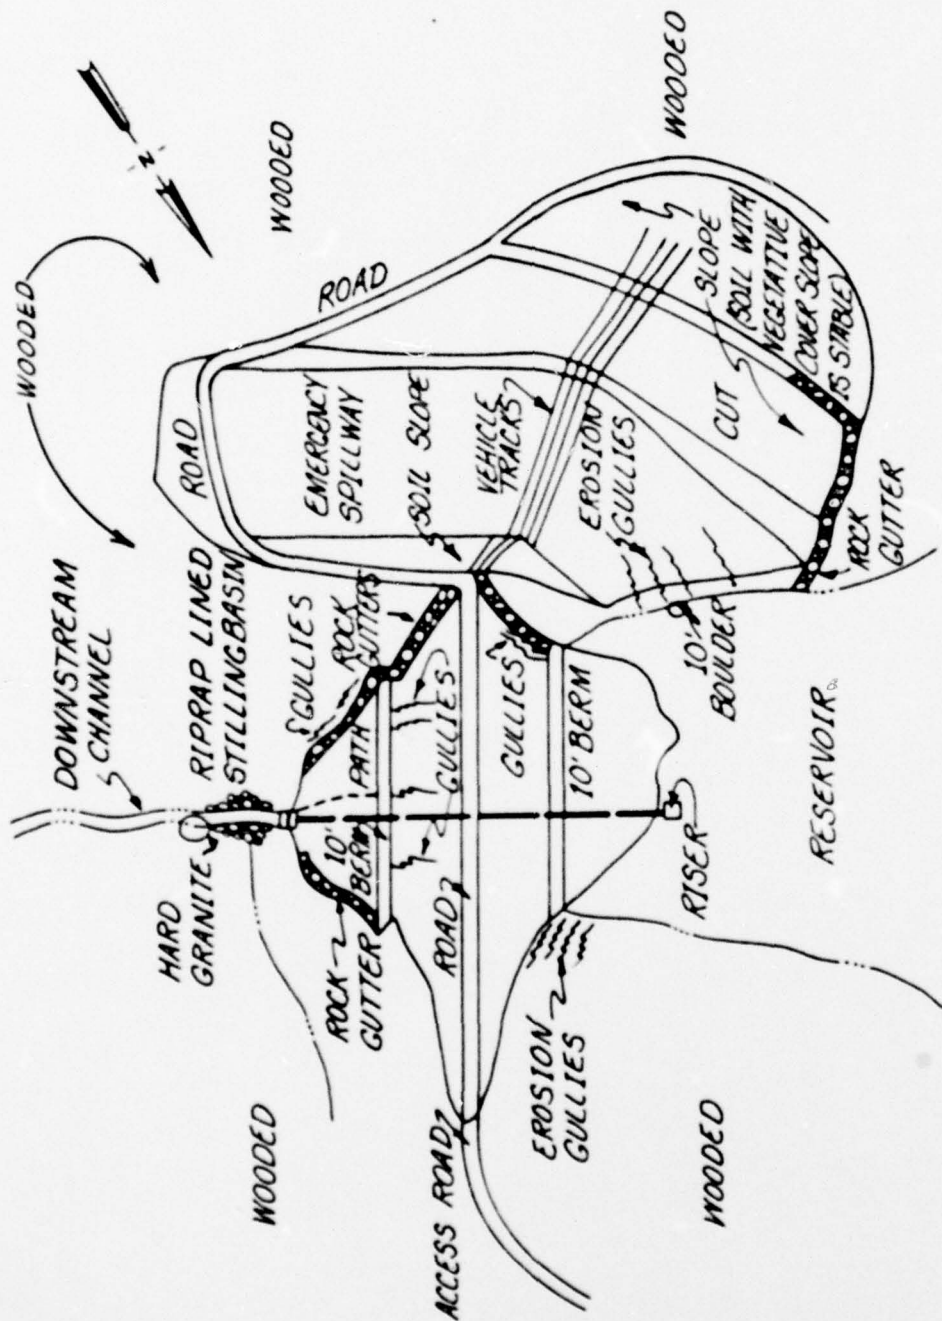
**FIELD SKETCH**  
 BUFFALO RIVER  
 DAM No. 3  
 Michael Baker, Jr., Inc  
 July 1979  
 PLATE I

- 3.1.3 Appurtenant Structures: The principal spillway was in good condition (see Photo 6). Small erosion gullies were observed in the approach channel of the emergency spillway. Several vehicle tracks are located across the emergency spillway and up the right cut slope (see Plate 1 and Photo 7).

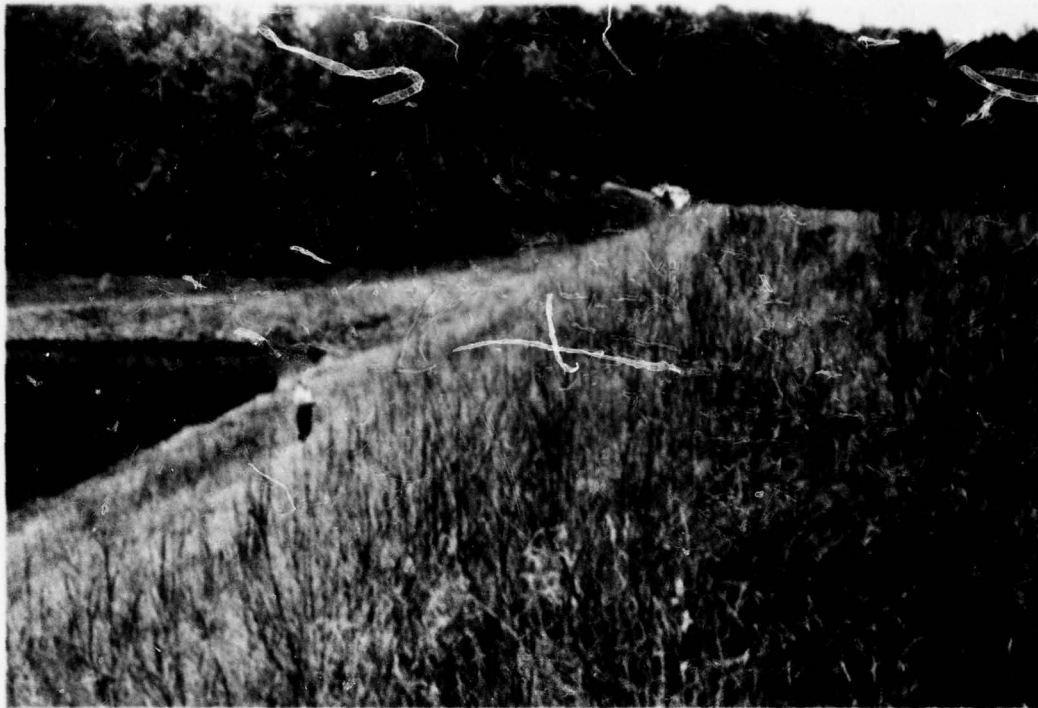
**PHOTO 1. Upstream Face of Dam Showing Tall Weeds in Grass**

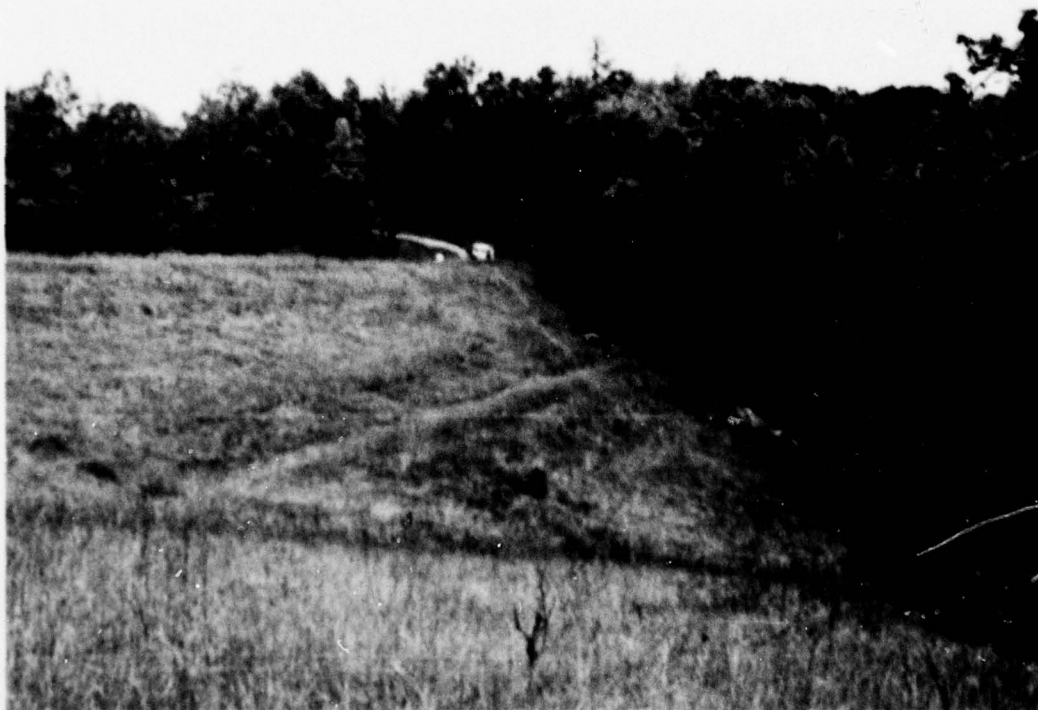
**PHOTO 2. Downstream Face of Dam Showing Tall Weeds and Bench**

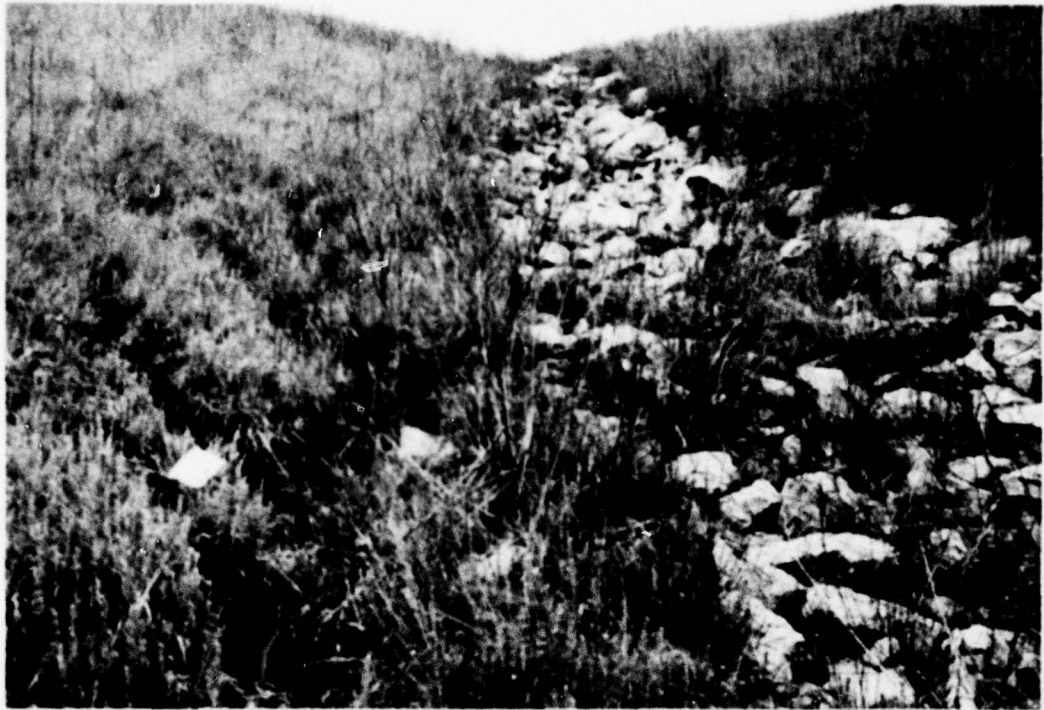
6.2.1 Visual Observations: No evidence of movement, i.e., bulging, tension cracks, or slumping, was noted on the embankment or beyond the toe. There do not appear to be deficiencies other than erosion gullies on three abutment slopes and above the 10 foot berm on the downstream slope. There was no visible seepage.

**PHOTO 3. Junction of Dam and Right Abutment (Upstream Slope)  
Showing Erosion Gullies Adjacent to Rock Slope Drain**

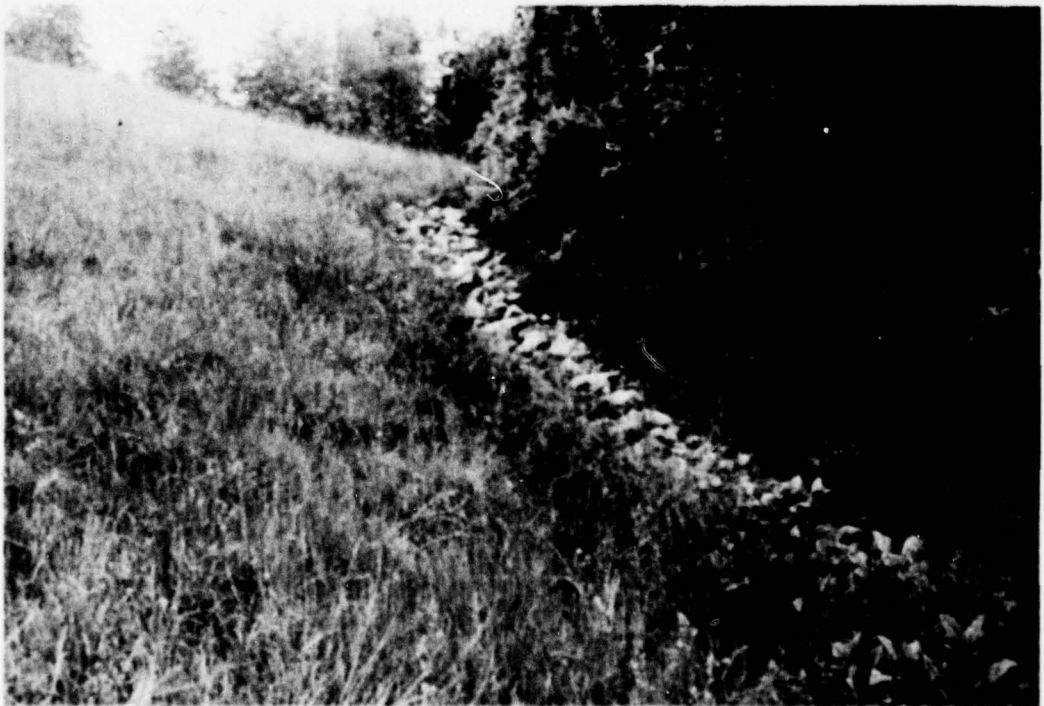
**PHOTO 4. Junction of Dam and Left Abutment with Rock Drain on Downstream Slope**

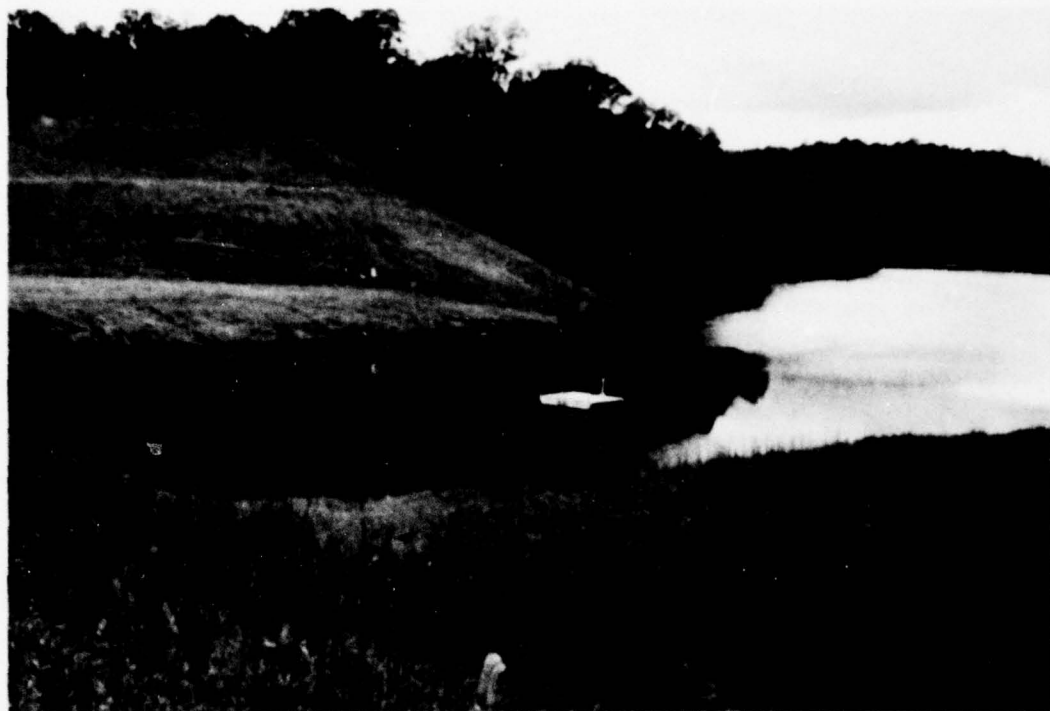
**PHOTO 5. View of Riser, Reservoir and Approach Slope of Emergency Spillway  
(Note Erosion Gullies in Approach Slope)**

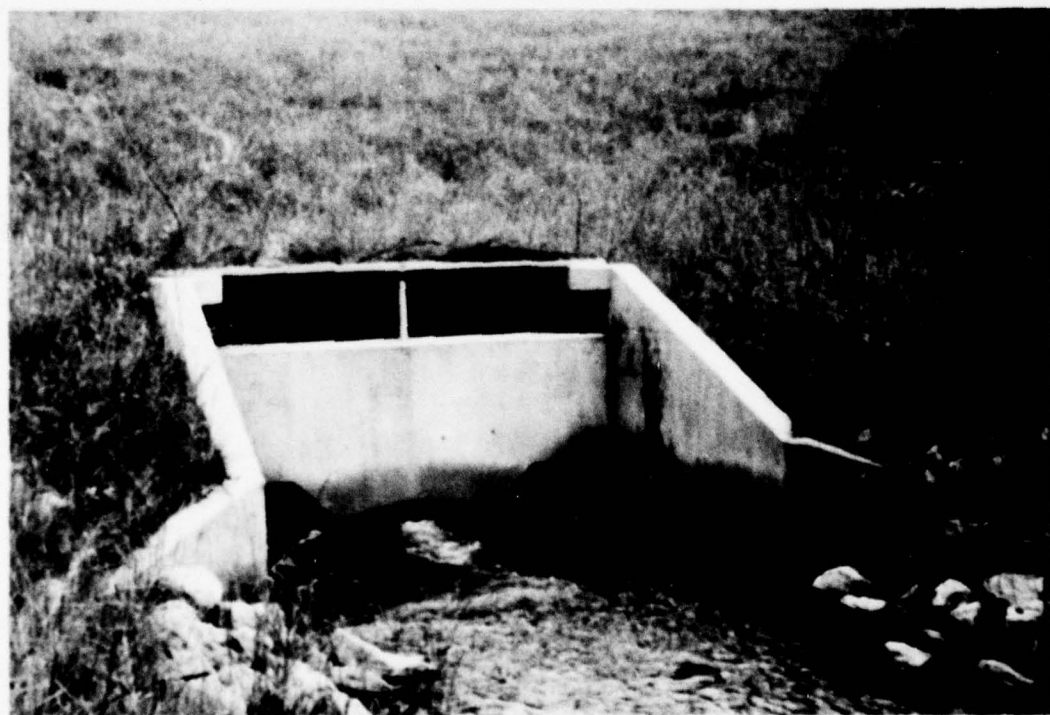
**PHOTO 6. Impact Basin with Baffle Wall and End Sill**

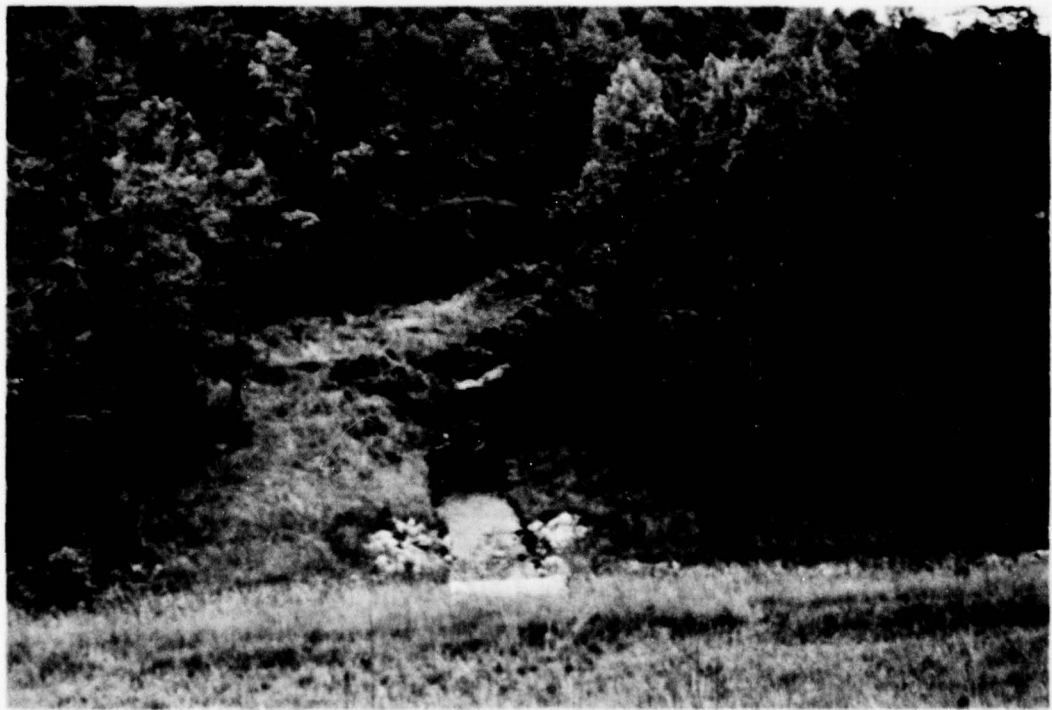
**PHOTO 8. Stilling Basin and Downstream Channel**
